**THE FAILURES OF THE MARS CLIMATE ORBITER AND MARS  
POLAR LANDER: A PERSPECTIVE FROM THE PEOPLE  
INVOLVED**

**Edward A. Euler and Steven D. Jolly**  
**Lockheed Martin Astronautics Operations Denver, CO**  
**H. H. 'Lad' Curtis**  
**ITN Energy Systems Littleton, CO**

**24th ANNUAL AAS GUIDANCE AND CONTROL CONFERENCE**

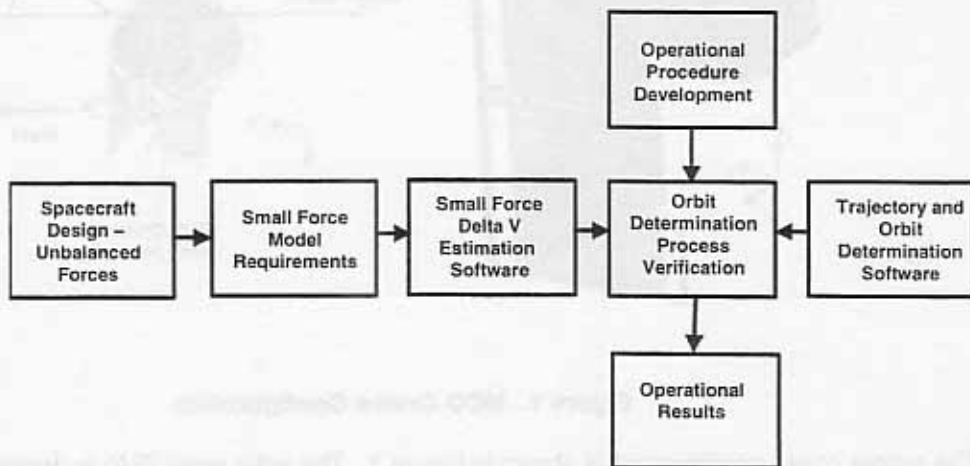
**Figure 2. Unbalanced Forces and Orbit Determination**

The orbit determination process must be able to account for all accelerations experienced by the spacecraft, especially those unbalanced forces imparted during autonomous momentum desaturations during the cruise phase of the mission (see Figure 2). MCO performed these reaction wheel desaturations approximately once every 17 hours, primarily due to asymmetric solar wind pressure on the spacecraft. The desaturations were predictable and were triggered by momentum buildup in the same axis since from early March '98 the same attitude was essentially maintained for all of the cruise mission. (From Launch until early March the spacecraft had remained in the launch attitude due to thermal constraints.) It is not possible to directly measure these small accelerations with MCO's IMU accelerometers, therefore each thruster pulse and duration was counted up during the mission and the thruster alignment and spacecraft attitude used to determine inertial direction of the imparted  $\Delta V$ .

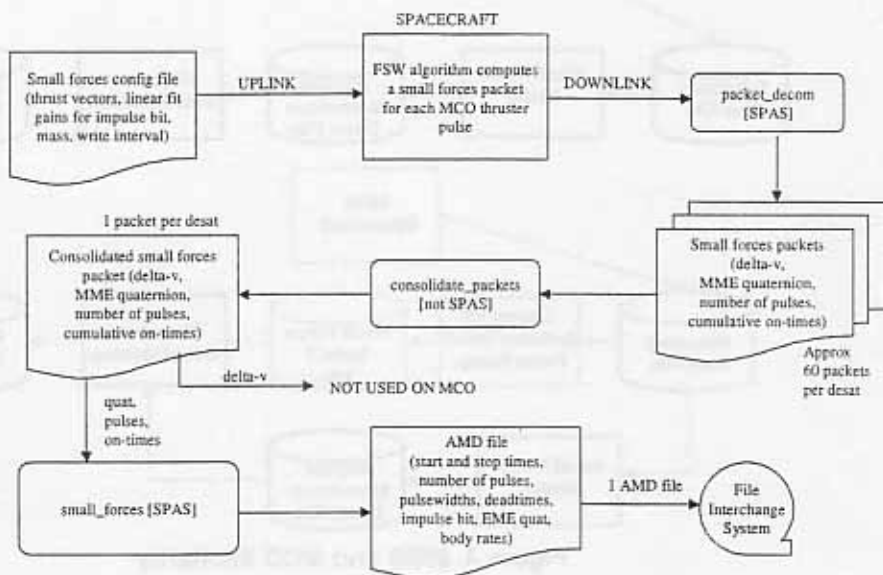
**Figure 3. AMD Process Flow**

Prior to April 16, 1999, there was 1 AMD file produced for every downlinked spacecraft small forces packet. Because of the sheer number of packets involved with every desat, the Flight and Navigation teams agreed to consolidate the packets into 1 AMD file per Desat event. This wasn't accomplished until about 4 months into the cruise phase where another ground routine consolidated the small forces packets into 1 packet per desat - still containing delta V, inertial delta-V vector, number of pulses, and cumulative on-times, before handing over to the SPAS tool.

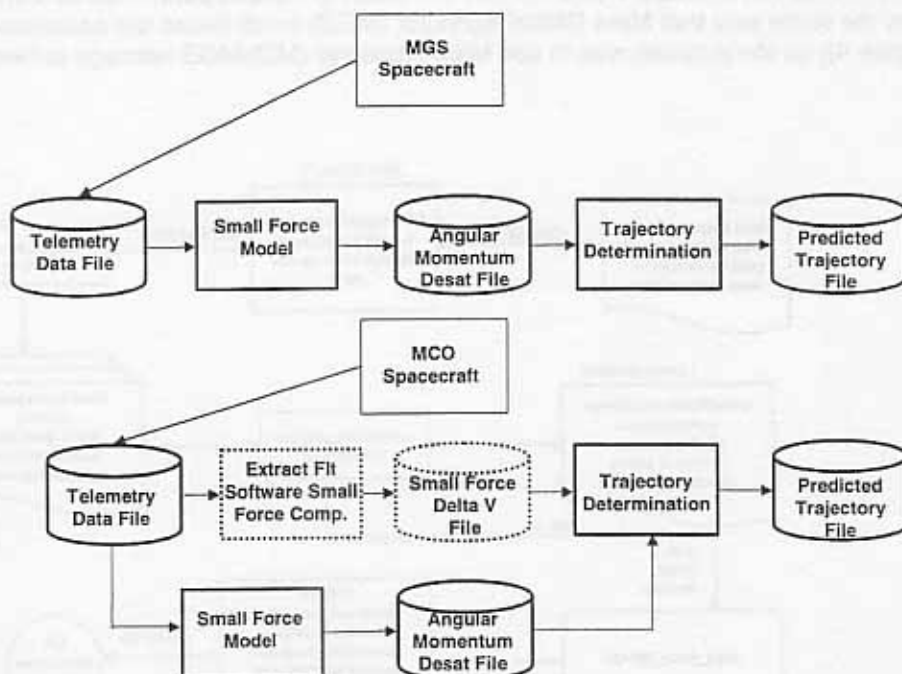
**Figure 4. MGS and MCO Similarity**

The equations used to make the I-bit calculation are vendor supplied and in English units (in the case of this vendor). Although starting from MGS-heritage software, the coded MGS thruster equation had to be changed because of the different size RCS thruster that MCO employed (same vendor). As luck would have it, the 4.45 conversion factor, although correctly included in the MGS equation by the previous development team, was not immediately identifiable by

inspection (being buried in the equation) or commented in the code in an obvious way that the MCO team recognized it. Thus, although the SIS required SI units, the new thruster equation was inserted in place of the MGS equation - without the conversion factor.

Requirements walkthroughs and subsequent code walkthroughs failed to expose the flaw, and in the formal S/W acceptance testing the "truth" AMD file (computed manually) used for comparison contained the same error as the acceptance test output file. Similarly, informal interface testing with the Navigation team did not test the truth of the file but concentrated on making sure it could be moved across on the file server.

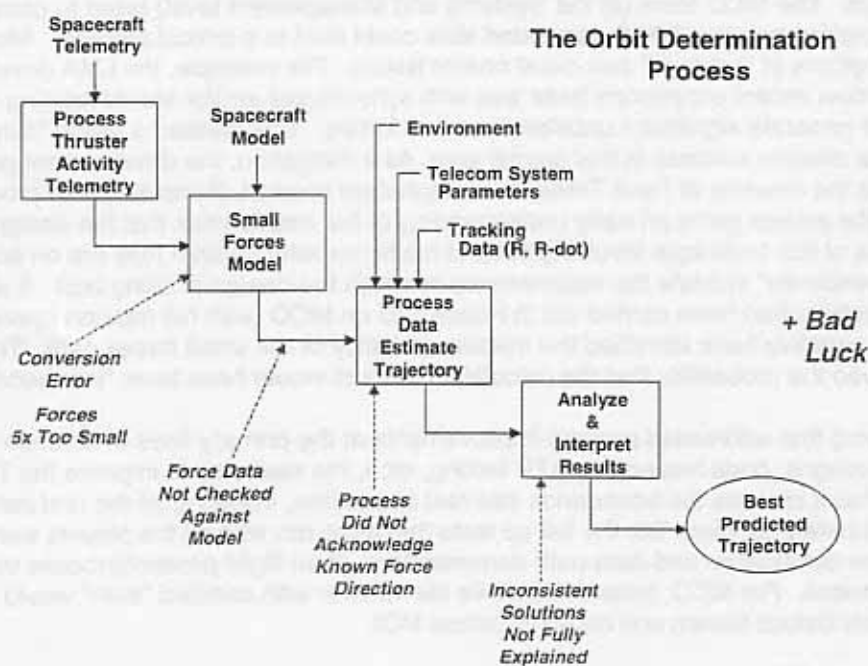
**Figure 5. Anatomy of MCO's Loss**

At 09:05:02 UTC (ERT), 39 seconds earlier than predicted, the spacecraft carrier dropped out completely as apparently Mars occultation had begun. Occultation was expected to end at 09:26:25 (using the actual occultation time) as reported by JPL. Unfortunately, the signal never appeared again. While the Flight Team continued to build the post-MOI burn predict during the occultation period, the navigation solutions continued to drop until finally reaching 57 +/- 1 km for MOI (P1) and 40 km for post-MOI periapsis (P2).

Thermal subsystem predictions show that the spacecraft would most likely have exceeded critical temperature limits at about 98 km. Attitude control authority would be exceeded at about 85 km altitude. It is believed that the spacecraft was lost as it approached periapsis following occultation. The MCO was approximately half way through the MOI burn when aerodynamic torques and heating caused the loss of control and possible break-up of the vehicle. It seems probable that the solar array broke off first and burned up in the atmosphere with some metallic parts getting to the surface of Mars. If the body of the MCO stayed together, the aerodynamic drag coupled with the partial MOI burn provides just about enough deceleration to capture into Mars orbit, so it is difficult to predict whether the MCO was captured or skipped out of the atmosphere to continue on an interplanetary trajectory. If captured, the body would plunge deep into the atmosphere on the next periapsis pass, eventually breaking up with some small pieces reaching the surface. Another possible outcome is that the aerodynamic effects during the MOI would cause catastrophic rupture of the propellant tanks, creating many small pieces, which again would burn up with some debris reaching the surface.

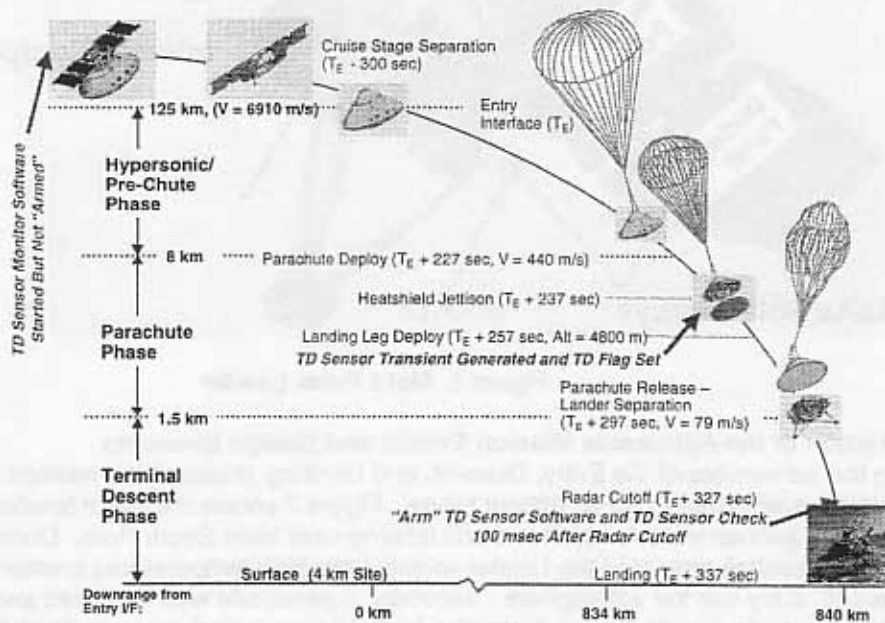
Figure 7. MPL Entry Descent and Landing Events

During the six minutes of the Entry, Descent, and Landing phase of the mission more than 30 mechanical events had to occur without failure. Figure 7 shows the event timeline. Three deceleration periods were to result in a soft landing near Mars South Pole. During Hypersonic Entry, the aeroshell protected the Lander vehicle from high temperatures created during direct, high speed, entry into the atmosphere. Secondly, a parachute was deployed and the heatshield was jettisoned. And lastly, twelve hydrazine fueled descent engines were fired during the last 1200 meters of free-flight to bring the Lander to a final relative velocity of 1.4 meters/second at touchdown.

The engines were required to be shutdown within 50 milliseconds of the first indication of contact with the surface in order to land without tipping over in the worst-case dynamics and slope conditions. A Hall-effect transducer was imbedded in the main attach point of each of the three landing legs to act as a touchdown (TD) sensor. Touchdown of a given leg would create a force and thus displace the leg until a permanent magnet in the leg strut created a signal out of the touchdown sensor. On-board flight software (FSW) sampled the three touchdown sensors at a 100 Hz rate. The first leg of the three to indicate touchdown caused the flight software to close all 12 descent engine valves within 25 milliseconds after the indication of touchdown.

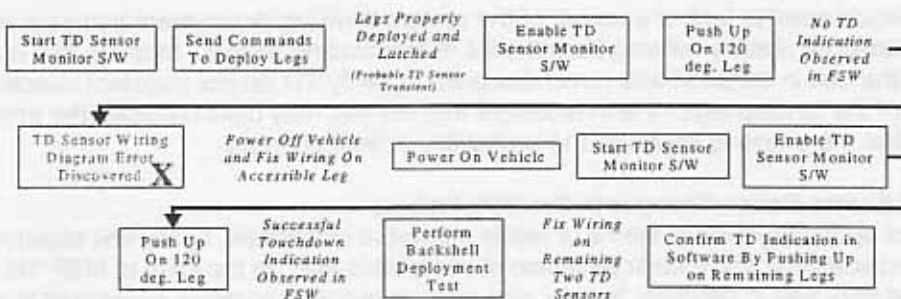
Figure 8. Leg Deployment Test Flow on the Flight Vehicle

The TD sensors had wire pig-tails extending out of the sensor that were to be wired to the main spacecraft harness. The connections were made for the first time based on engineering instructions that were erroneous. If the wiring had been correct, and if the leg deployments on the test floor created sufficient transients on the TD sensor lines, then the system level leg deployment test could have identified the logic error. As it was, the system level leg deployment test did identify the wiring error (see next section). Prior tests of the TD sensor logic utilized a flight-spare TD sensor in a special fixture which was manipulated manually by a technician to simulate touchdown. In the change-over from the TD sensor simulator to the flight units the wiring error was introduced into the test flow.

Several items made the check-out of the TD sensor wiring difficult to perform. The magnet used to stimulate the Hall Effect transducer during flight was physically separated from the transducer when the legs were in the stowed position. Consequently an external test magnet had to be used to induce a change in the TD sensor signal. In addition, the severe restrictions on spacecraft launch mass resulted in the deletion of connectors between TD sensors and spacecraft harness which contributed to the wiring checkout difficulty. The fact that an error was made in the TD sensor wiring engineering was driven more by the factors just discussed than any problem with the process that generated the wiring instructions. The spacecraft wiring diagrams were produced through a customary process of design reviews with each subsystem, automated harness checkout electronics, and configuration controlled engineering.

This test might have detected the TD sensor logic flaw if not for the sensor wiring problem. It is not certain though that the specific physics of the test (i.e. 1 g and physical mounting) would have resulted in rebound of the landing legs and enough of a TD sensor transient to trigger touchdown flag. At the time of the test there was no discussion of repeating the test as it had accomplished the test objectives. The cause of the TD sensor anomaly during the test was obvious, it was documented, fixed, and verified. If we would have recognized that there was a dynamic effect occurring with the TD sensors during leg deployment then the test results would have been evaluated for a potential repeat. Perhaps if TD sensor transients were better defined (item 3) the team might have used this system level test to verify the software logic. A repeat of the leg deployment test would have resulted in disassembly of the flight vehicle and a potential recycle through some system level environmental testing to recreate the same series of events at the time of the original leg deployment test.
